January 8, 2019

There's traffic. And then there's Chicago traffic.

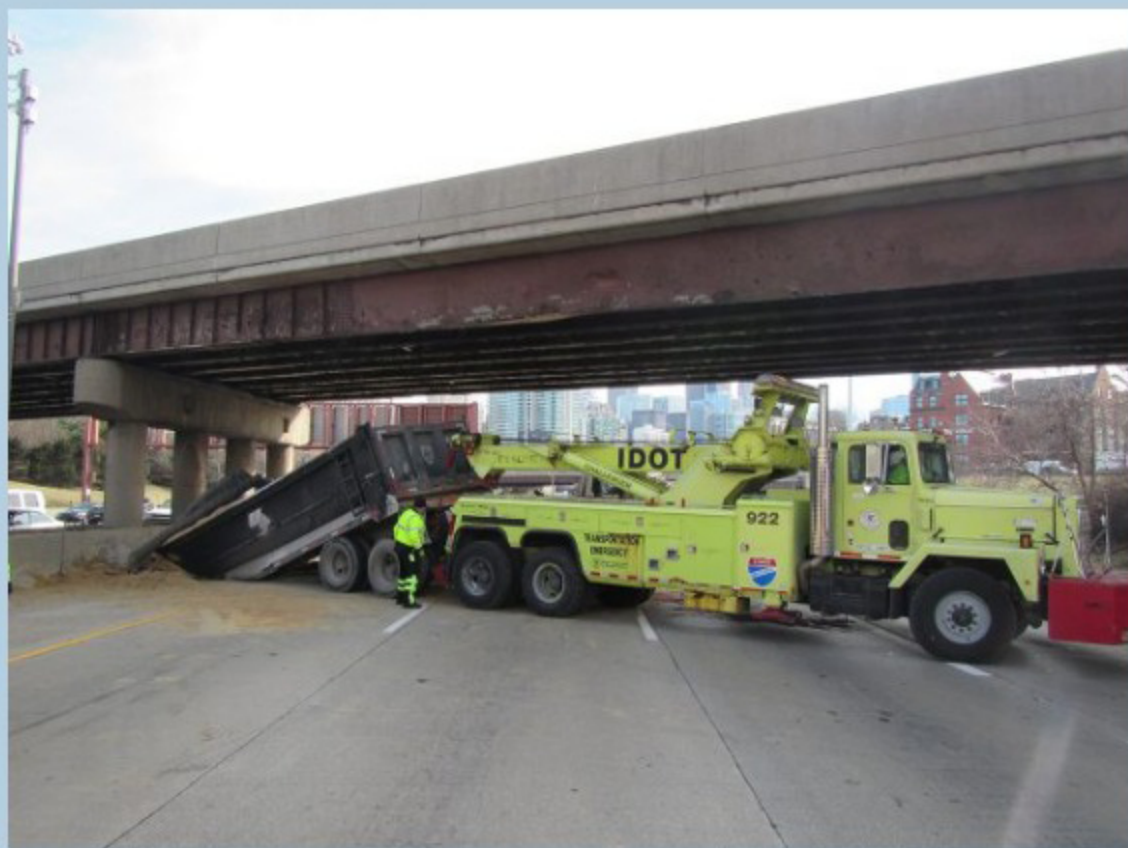
When the raised bucket hit the underside of a bridge, not only was the bucket ripped off and the truck flipped, the heavy steel girder on the north side of the bridge was severely bent. Fortunately, the pavement on the bridge was intact and only one lane had to be closed. But repairing the bridge posed a serious challenge. Closing the bridge and the expressway below to replace the girder was out of the question. Disrupting that much traffic is simply a non-starter.
