## Pipeline Bridge

### Trains, barges, and overhead pipelines

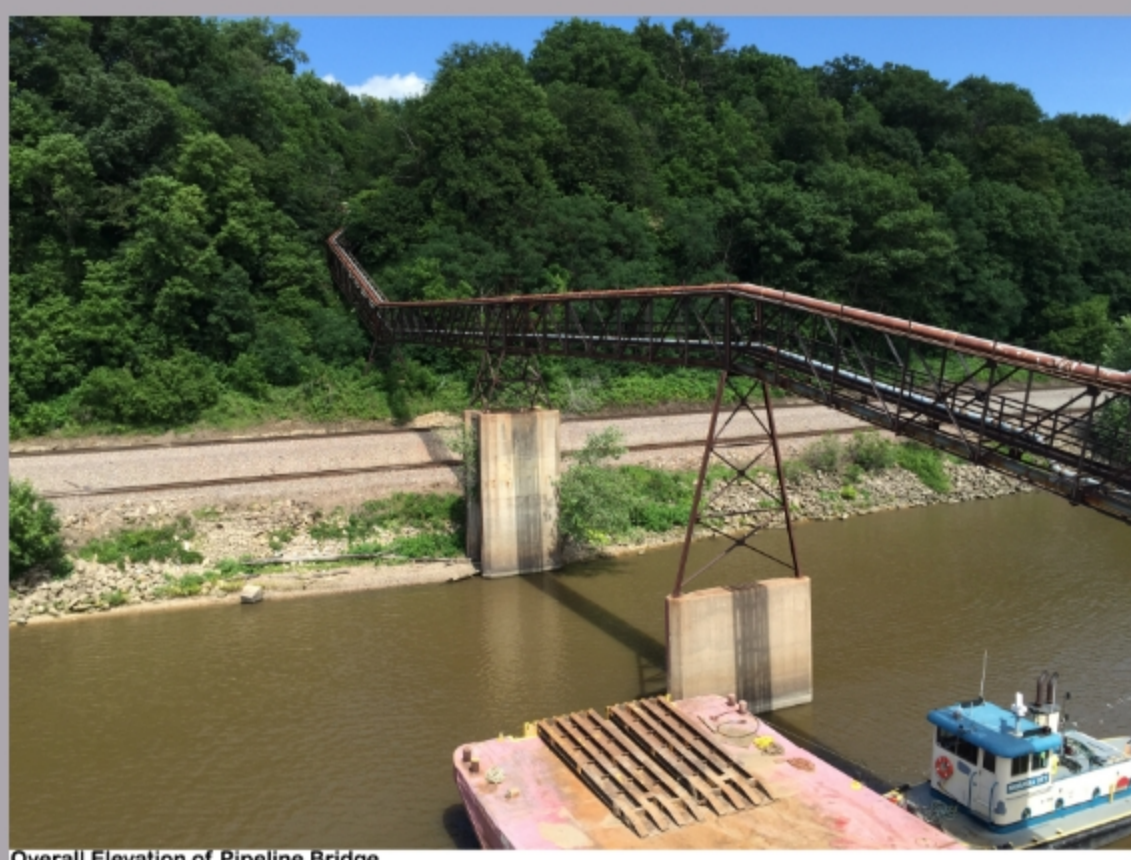
Overall Elevation of Pipeline Bridge

The plant is located adjacent to the Mississippi River and has been loading and unloading its primary products used to make fertilizer onto barges for almost 50 years. The overhead pipeline that carries UAN, ammonia and other chemicals are supported by a bridge structure that extends 300 feet into the river. On the way from the plant to the barge loading facility, the pipeline bridge crosses over a 140-foot bluff and an active railway.

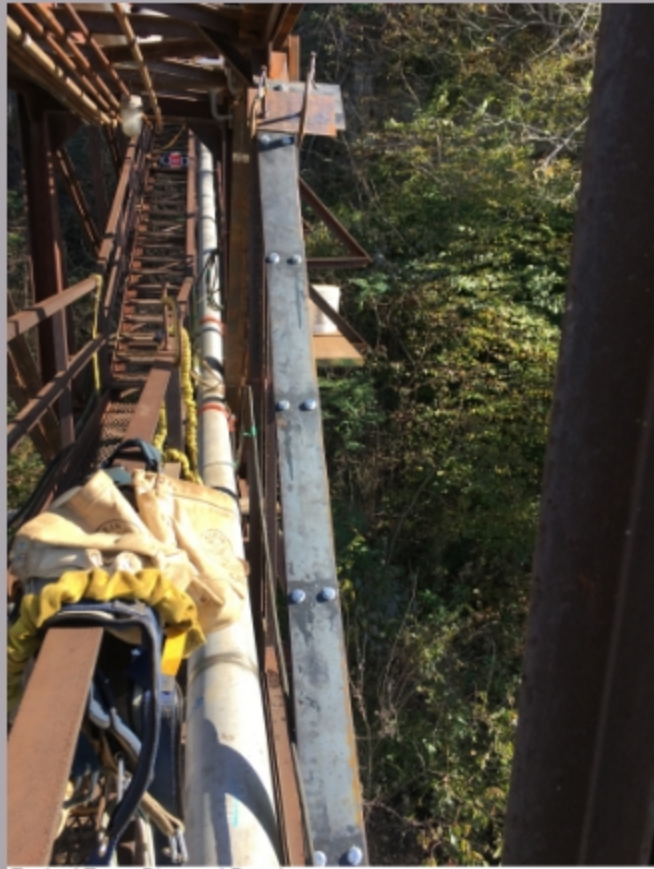
During a routine inspection triggered by an air rights contract renewal, the bridge was found to have significant deterioration due to rust and general aging. A contractor was brought in to make the repairs and everything seemed fine.

Typical Truss Diagonal Repair

When it was originally built, large sections of the bridge had been prefabricated, with welded joints, then lifted and assembled into place using bolted connections. But, while simple and fast, the contractor's suggestion of using welding to repair the bridge deterioration would have introduced a whole new set of residual stresses that the original design didn't account for. The structure could have risked collapse from the very repairs meant to fix it.

After a complete review of the bridge using complex modeling, analysis, and a

variety of loading scenarios, WHKS engineers developed a repair strategy that would return the bridge to a condition acceptable to the railway, minimize temporary support structures and keep costs reasonable.
