Just a little off the top, please!

Baumann Road over I-70 Bridge Deck Replacement

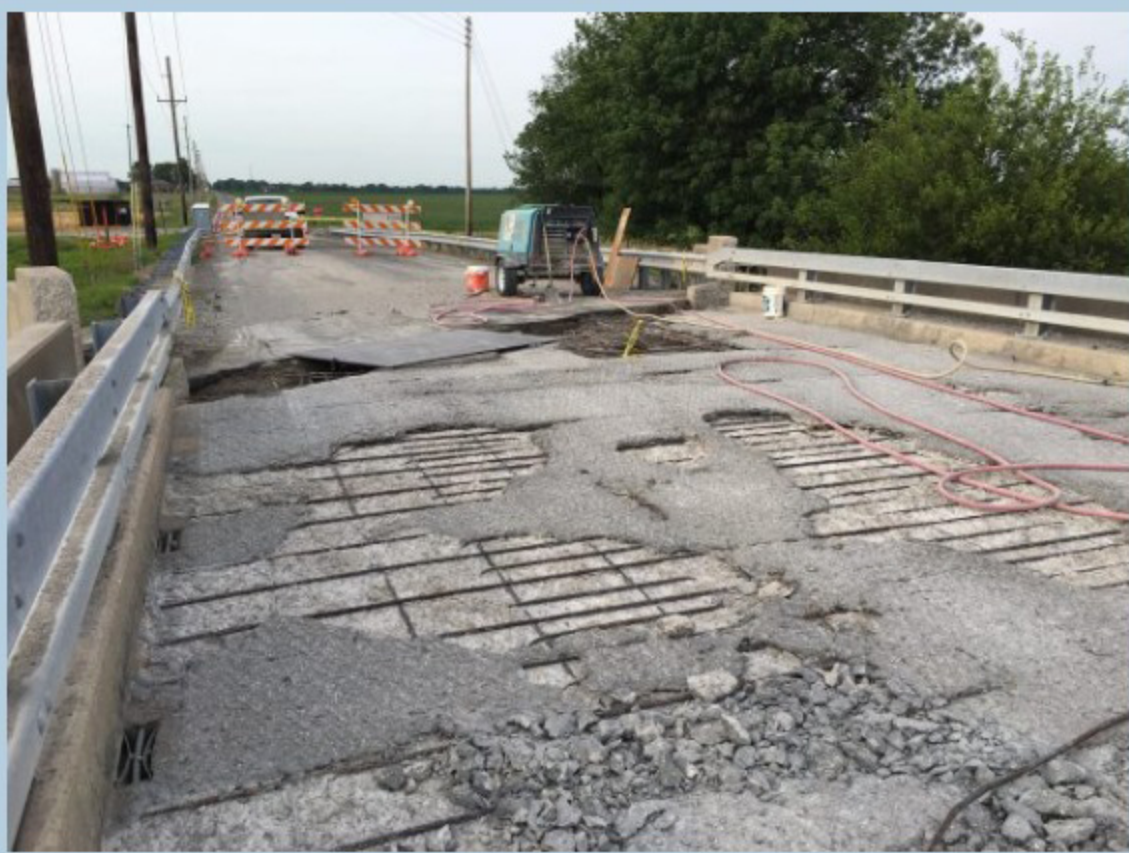
But half a century of road salt had reacted with the old concrete, weakening its internal bonds and, instead of removing the first inch or so, the high-pressure water blew right through the entire bridge deck! Suddenly, instead of looking at a healthy thickness of concrete, the contractor was staring at daylight from below.

Damaged Deck After Hydro-Scarification

A thorough inspection showed that the bridge abutments, piers and girders were in fine shape but the deck had to be replaced. The design also called for new structural bearings in several locations, a number of upgrades to address changes in the seismic codes and a traffic management plan for I-70 during the repair work.

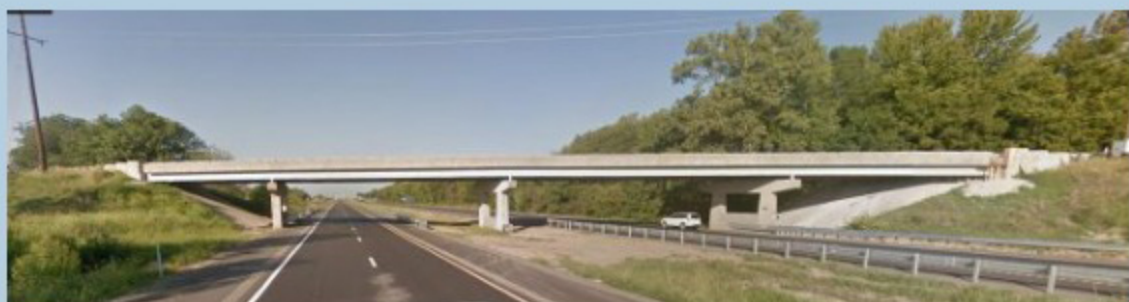
View of Baumann Road Bridge from I-70

Responding to the hurry-up call from IDOT, WHKS took just three months to inspect the bridge, survey the structure, prepare both preliminary and final plans, specifications and cost estimates and a traffic management plan for I-70.
